SEVERN RIVER

PRELIMINARY WATERSHED AUDIT

November 15, 2011

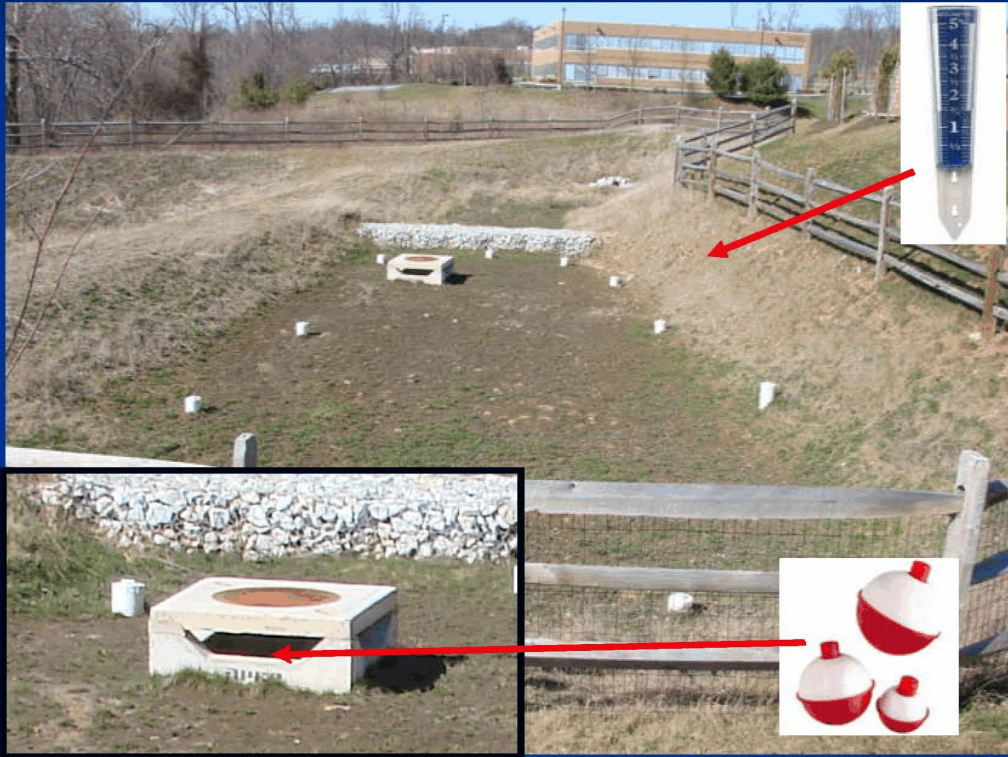
Rain Gauge & Float Method

Water Quality
Volume
1-inch runoff
from impervious
surfaces.

1.2-inches of rain
generates **1.0**-inches
of runoff from
impervious surfaces.
